Antares Hydraulic DCDC Control Circuit ECO

Dave Nadler (DRN)

Overview

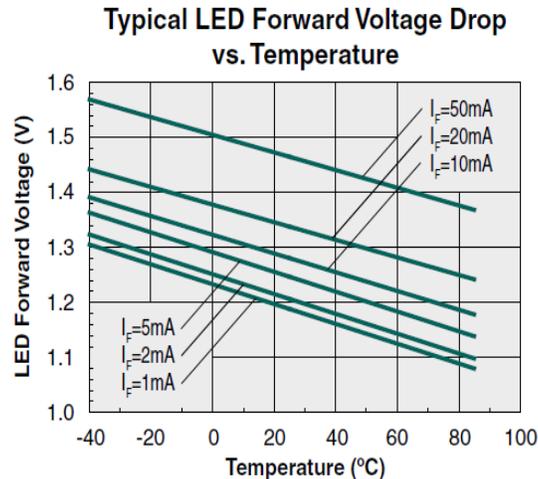
Opto-isolators such as IXSYS (Clare) CPC1018 or LCB110 use an GaAlAs infrared LED. This is a current-mode device, with typical **recommended minimum operating current of 1ma** (for CPC1018 at 25C). The forward voltage drop of the diode is highly temperature-dependent and current-dependent; from the [CPC1018 Datasheet](#): for $I_f=10\text{ma}$ $V_f=1.4$ at -40C to around 1.2 at 80C .

From the above chart and CPC1018 data-sheet:

- maximum required current to turn on is 1ma at 25C; below 1ma the opto-isolator may not switch.
- 1ma turn-on is valid at 25c, but required current increases with temperature (3ma at 60C).
- with a 1.2v supply, current drops below 1ma as temperature drops below 19C (typical value).
- with a 1.25v supply, current drops below 1ma as temperature drops below -10C (typical value).

The hydraulic DCDC supply control uses an LR8 voltage source to drive two CPC1018 opto-isolators. Current production schematic v4.4 shows the two optos in series for a nominal 1.225v (LR8 2.43v divided by 2). The graph above shows 1.22v is below the 1ma curve required to turn on the opto at temperatures below 0C. While the LR8 set-point resistors are 1%, the regulator is +/- 5% or +/- .06v. **Thus in v4.4, opto switch-on is marginal and becomes increasingly unreliable at low temperatures, as the LR8 supply voltage is well below the required switch-on value.** This can be easily tested (in an Antares or on the bench) using a can of Freeze-It.

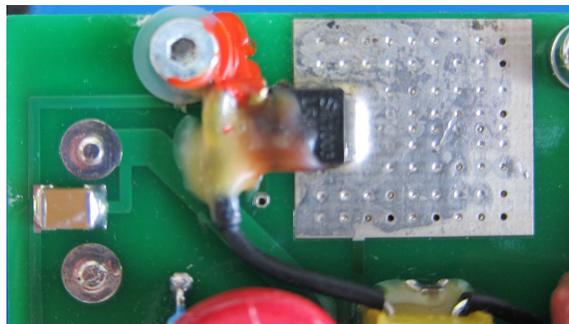
In a 20E at Lange, the measured LR8 temperature after hours powered on with ambient $\sim 20\text{C}$ is 65C (in v4.2 aircraft prior ECO). That's external temperature with a large heat-sink area; T_j will be much hotter (from datasheet, typically 125C). However, in Buchanan's 20E the epoxy slobbered over the regulator was badly discolored, indicating severe overheating:

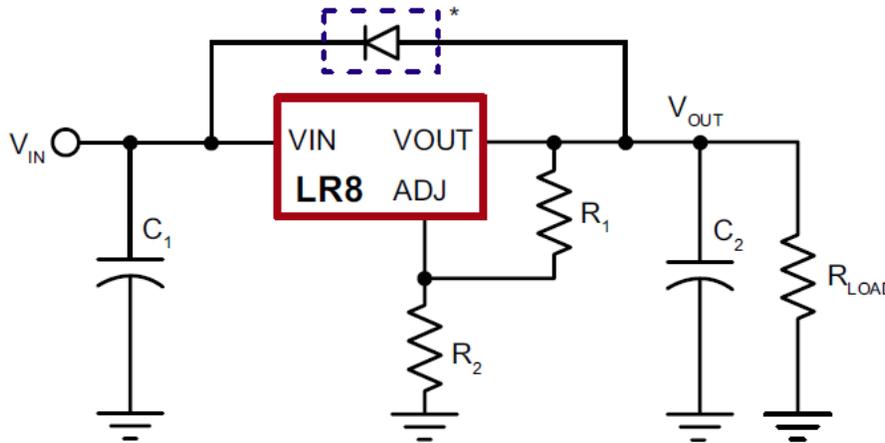
Here's the typical LR8 application circuit from the Supertex data sheet:

* Required for conditions where V_{IN} is less than V_{OUT}

The absolute maximum reverse-bias allowed across the LR8 is .5v. The protection diode on the top is nominally required to prevent back-biasing the LR8 regulator.

When using high V_{IN} such as with Antares 288v, a protection diode as suggested above is not feasible, as diodes rated for 300v have a conduction voltage drop greater than 0.6v. This forward drop is higher than the .5v drop required to protect the LR8. Instead, a series diode should have been used (between V_{IN} and C_1).

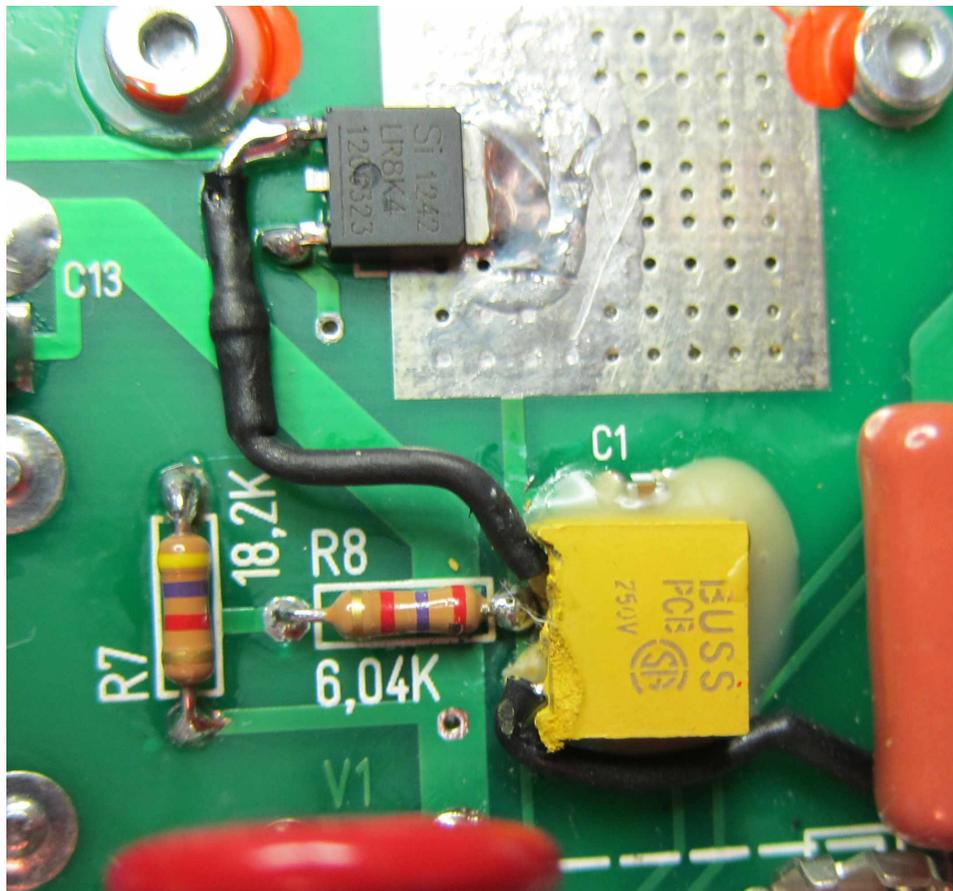
Change R7 to 5.11k 1%, change R8 to 2.21 1%. Bend the resistor leads and trim them very short, so there is no possibility the leads can touch the Vicor part underneath the through-holes where the resistors are installed. Replace the LR8 with a new part.

WARNING: If the fuse (yellow square above) has been badly placed with its leads very close to resistor R8 lead as above, make sure to add insulating lacquer between R8 terminal and fuse leads – fuse leads are 288 volts !!!

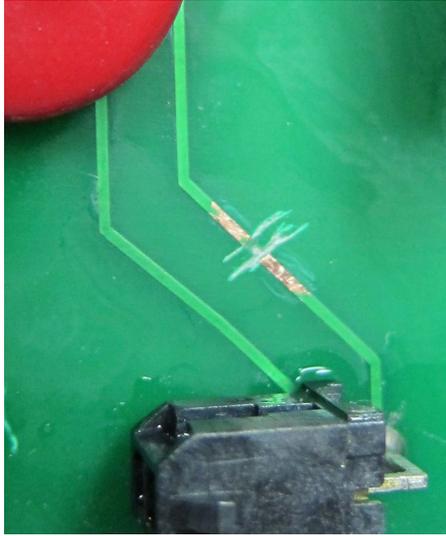
Cut the trace grounding the opto-isolators just above the switching-line Molex connector, and clean top of trace, removing just enough trace material to leave space for a 1206 resistor like this:

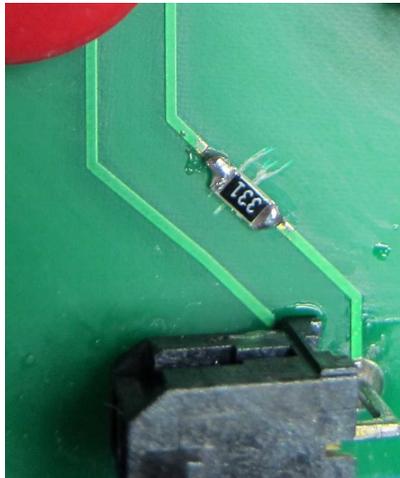
Install the 330 453 ohm series resistor like this:

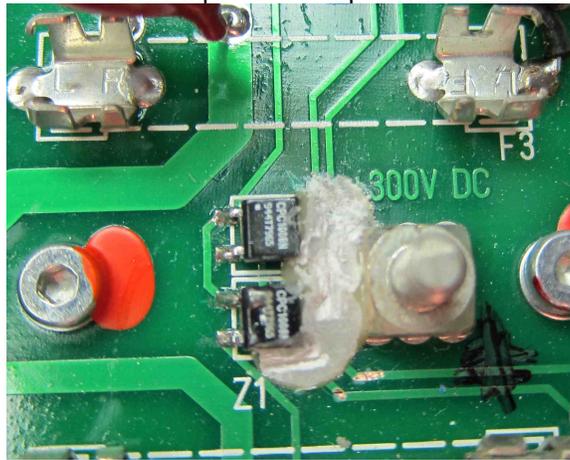
The board may have a gigantic goober of epoxy on the opto-isolators (to the left of the “300v” label), installed to try and rectify unsafe clearance between 288v input and components or traces:

Carefully remove the epoxy goober while cursing violently at whatever idiot made this mess (work slowly with hot-air soldering station to melt). Remove the opto-isolators, and clean the board, after which it should look like this:

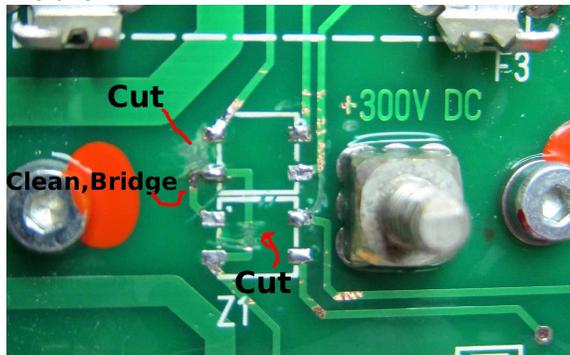
Cut the two bridges pin1-pin1 and pin2-pin2, then clean part of the left bridge and make a solder-bridge from top pin2 to bottom pin 1, so it looks like this:

Install two new CPC 1018 opto-isolators (take care to preserve the solder bridge), and clean.

WARNING: Make sure to add insulating lacquer over opto leads and traces near 300v stud !!!
